## **TECHNICAL MEMORANDUM**

**From:** Mohan Thampi, PE, Project Manager, CAP Engineering  
Rolando Alvarez, EI, Project Engineer, CAP Engineering

**RE:** **Evaluation of Options for Possible Immediate Road Repairs for NW 6<sup>th</sup> Avenue, NW 7<sup>th</sup> Avenue, NW 9<sup>th</sup> Avenue, NW 10<sup>th</sup> Avenue, NW 11<sup>th</sup> Avenue, NW 12<sup>th</sup> Avenue, SW 5<sup>th</sup> Avenue, and SW 6<sup>th</sup> Avenue, and SW 11<sup>th</sup> Avenue (DRAFT)**

### 1. NW 6<sup>th</sup> Ave Evaluation

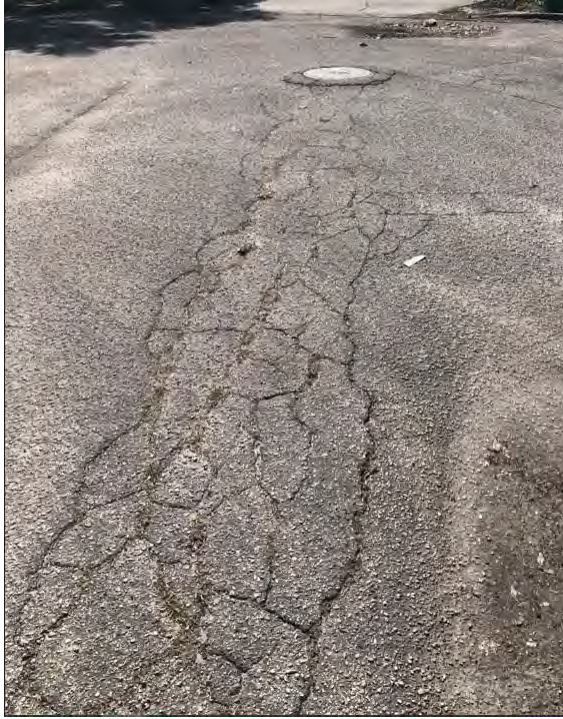
Figure 1.0 and Figure 1.1 below displays typical longitudinal cracks running a course approximately parallel to the centerline of the roadway. These cracks are result from earth movements, particularly on embankments. Two or more closely-spaced longitudinal cracks as shown in the figures below indicate bending stress induced by rutting. Longitudinal cracks can also occur as a result of movement in the pavement beneath the asphalt pavement layer (base and subbase settlement).

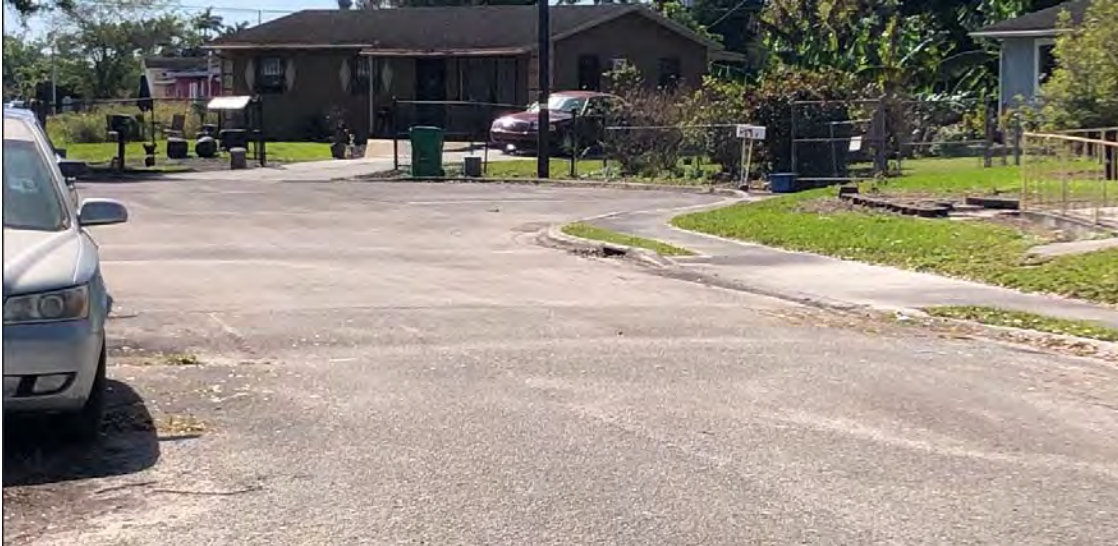
*Figure 1.2*

Depressions found on NW 6<sup>th</sup> avenue can mainly be attributed to movement of the roadway base and subbase. Consolidation or lateral movement under traffic in one or more of the underlying causes, or by displacement in the surface layer itself can cause similar depressions to form. Depressions such as those seen in Figure 1.2 and Figure 1.3 are of main concern along NW 6<sup>th</sup> avenue. These current conditions are currently causing drainage deficiencies that further affect the longevity of the road.

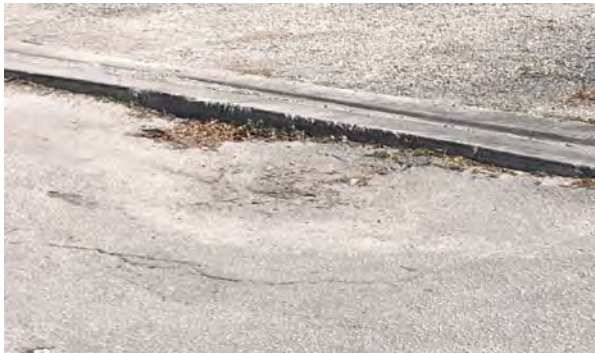
*Figure 1.4*

Proper drainage is essential to preserve the design life of the roadway. Although not shown due to dry conditions at the time of inspection, standing water on the pavement is a constant issue in this roadway due to the sinking observed at the intersection causing water to flow away from the inlets. Sinking of the road around inlets and curb and gutter has also severely impacted the ability to drain properly. Figures below some of the conditions mentioned above.

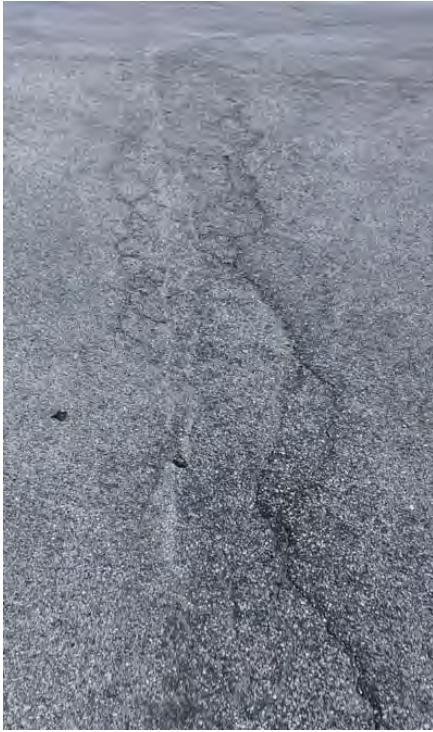
Figure 2.0 and Figure 2.1 below displays typical longitudinal cracks running a course approximately parallel to the centerline of the roadway. These cracks are result from earth movements, particularly on embankments. Two or more closely-spaced longitudinal cracks as shown in the figures below indicate bending stress induced by rutting. Longitudinal cracks can also occur as a result of movement in the pavement beneath the asphalt pavement layer (base and subbase settlement).

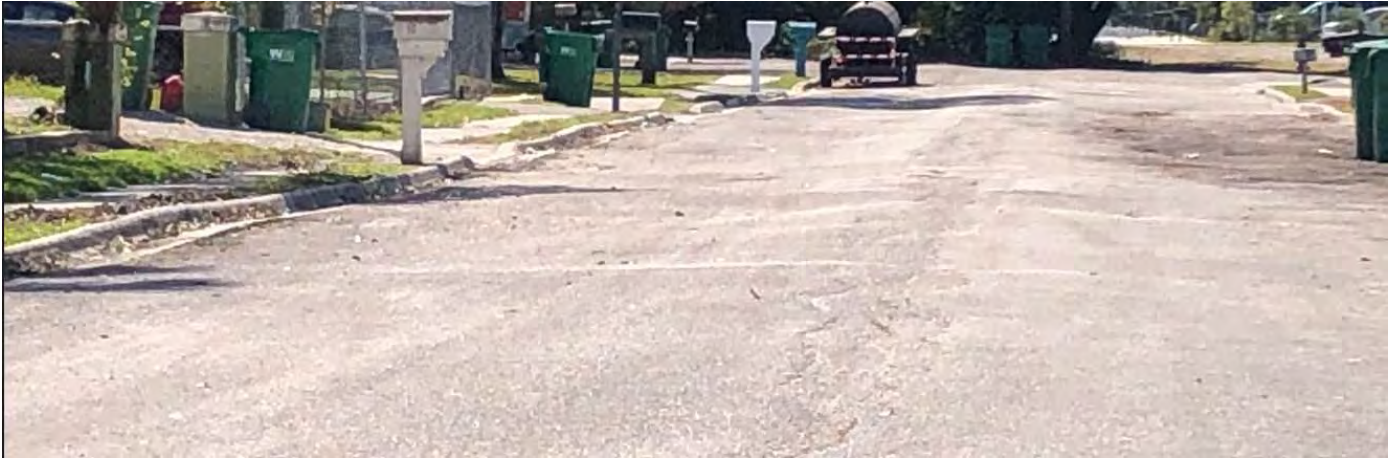
Depressions found on NW 7<sup>th</sup> avenue can mainly be attributed to movement of the roadway base and subbase. Consolidation or lateral movement under traffic in one or more of the underlying causes, or by displacement in the surface layer itself can cause similar depressions to form. Depressions such as those seen in Figure 2.2 are of main concern along NW 7<sup>th</sup> avenue. These current conditions are currently causing drainage deficiencies that further affect the longevity of the road.

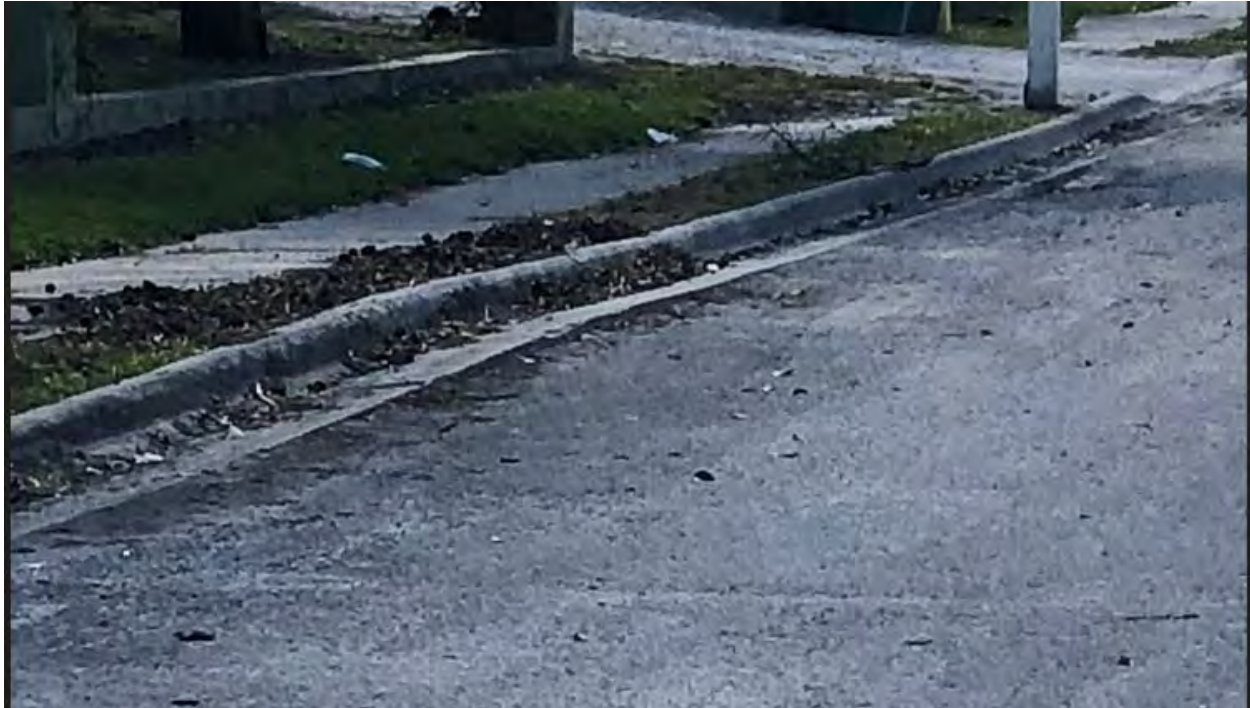
*Figure 2.3*

Proper drainage is essential to preserve the design life of the roadway. Although not shown due to dry conditions at the time of inspection, standing water on the pavement is a constant issue in this roadway due to the sinking observed at the intersection causing water to flow away from the inlets. Sinking of the road around inlets and curb and gutter has also severely impacted the ability to drain properly. Figures below show some of the conditions mentioned above.

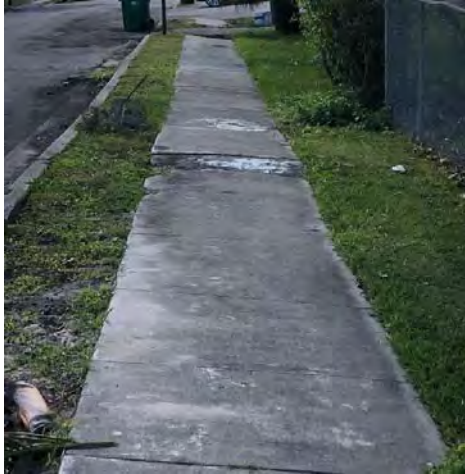
Sidewalk damage can be seen at multiple instances along NW 7<sup>th</sup> avenue. Conditions such as cracking and uneven settlement were observed. Probable causes to sidewalk deficiencies observed can be attributed to weak soil structure and or vehicular load. Many locations were observed to be unsafe and are a potential trip hazard that need to be addressed as soon as feasible. Conditions shown Figure 2.4 and 2.5 represent typical deficiencies found.

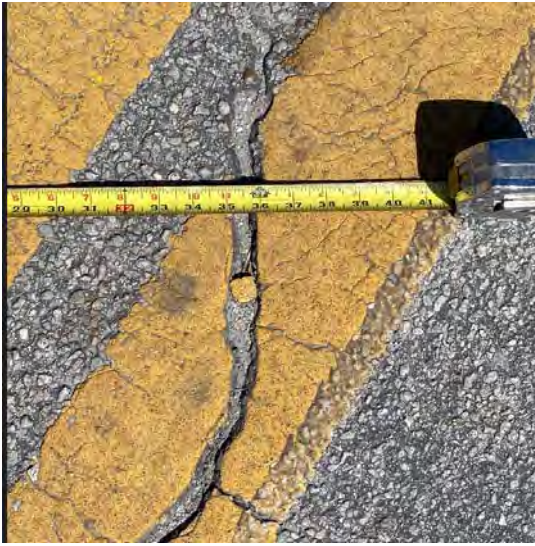
Figure 3.0 and Figure 3.1 below displays typical longitudinal cracks running a course approximately parallel to the centerline of the roadway. These cracks are result from earth movements, particularly on embankments. Two or more closely-spaced longitudinal cracks as shown in the figures below indicate bending stress induced by rutting. Longitudinal cracks can also occur as a result of movement in the pavement beneath the asphalt pavement layer (base and subbase settlement).

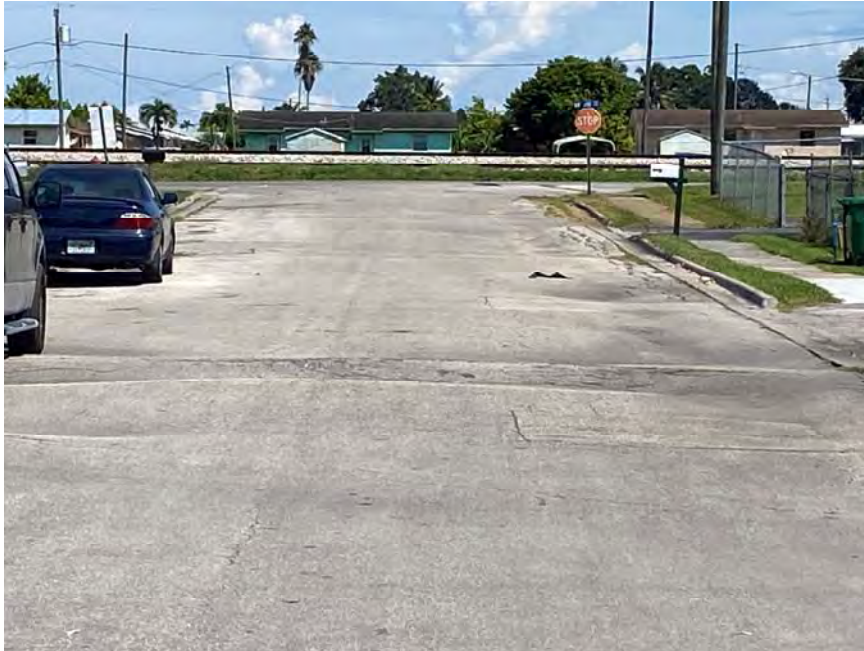
*Figure 3.2*

Depressions found on NW 9<sup>th</sup> avenue can mainly be attributed to movement of the roadway base and subbase. Consolidation or lateral movement under traffic in one or more of the underlying causes, or by displacement in the surface layer itself can cause similar depressions to form. Depressions such as those seen in Figure 3.2 are of main concern along NW 9<sup>th</sup> avenue. These current conditions are currently causing drainage deficiencies that further affect the longevity of the road.

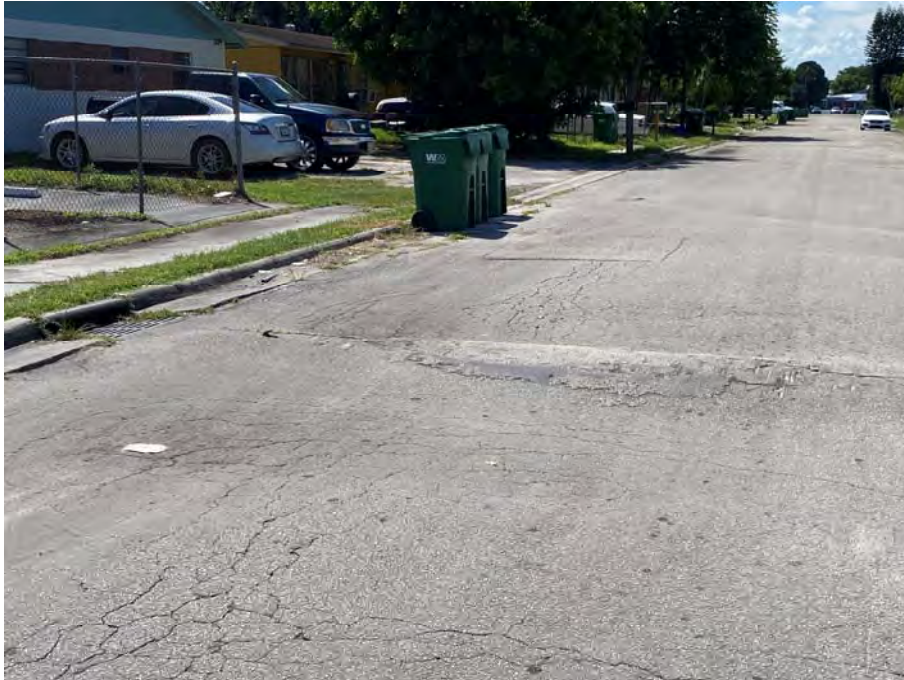
*Figure 3.4*

Proper drainage is essential to preserve the design life of the roadway. Although not shown due to dry conditions at the time of inspection, standing water on the pavement is a constant issue in this roadway due to the sinking observed at the intersection causing water to flow away from the inlets. Sinking of the road around inlets and curb and gutter has also severely impacted the ability to drain properly. Figures below some of the conditions mentioned above.

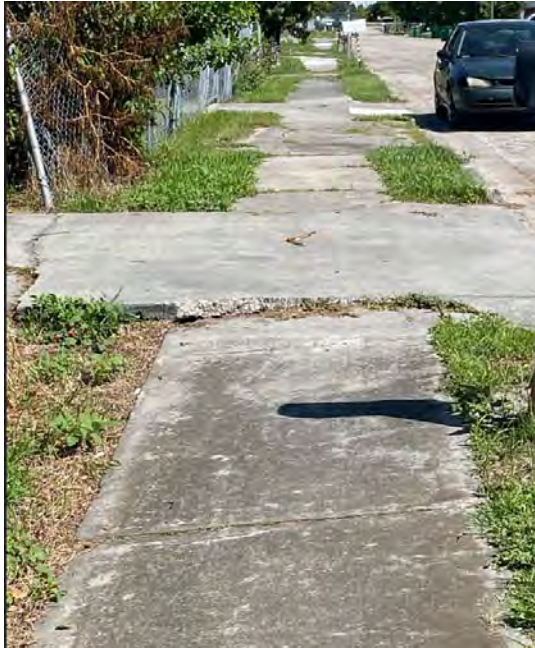
Figure 3.5

Sidewalk damage can be seen at multiple instances along NW 9<sup>th</sup> avenue. Conditions such as cracking and uneven settlement were observed. Probable causes to sidewalk deficiencies observed can be attributed to weak soil structure and or vehicular load. Many locations were observed to be unsafe and are a potential trip hazard that need to be addressed as soon as feasible. Conditions shown Figure 3.5-3.9 represent typical deficiencies found.

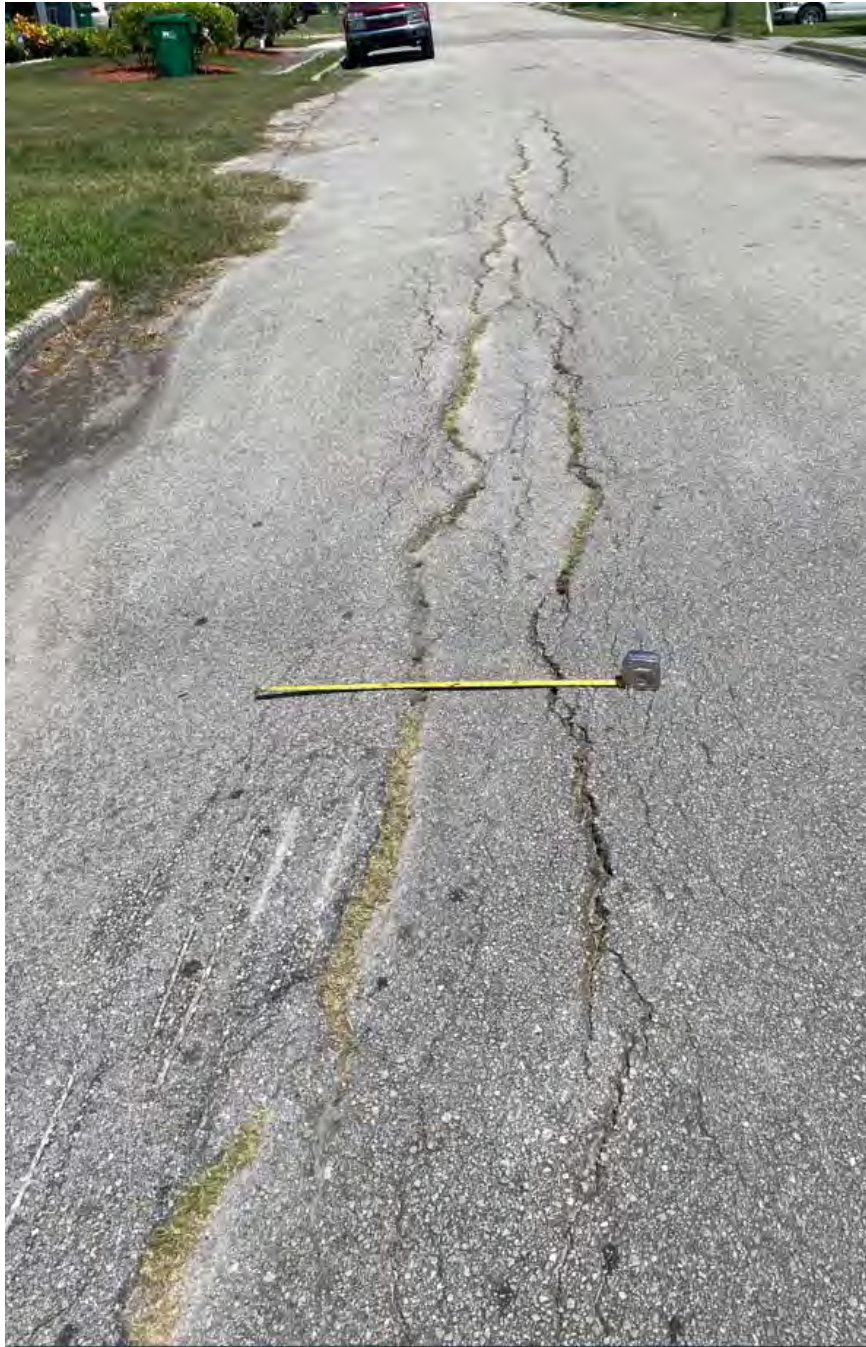
*Figure 4.0*

Figure 4.0 below displays typical longitudinal cracks running a course approximately parallel to the centerline of the roadway. These cracks are result from earth movements, particularly on embankments. Two or more closely-spaced longitudinal cracks as shown in the figures below indicate bending stress induced by rutting. Longitudinal cracks can also occur as a result of movement in the pavement beneath the asphalt pavement layer (base and subbase settlement).

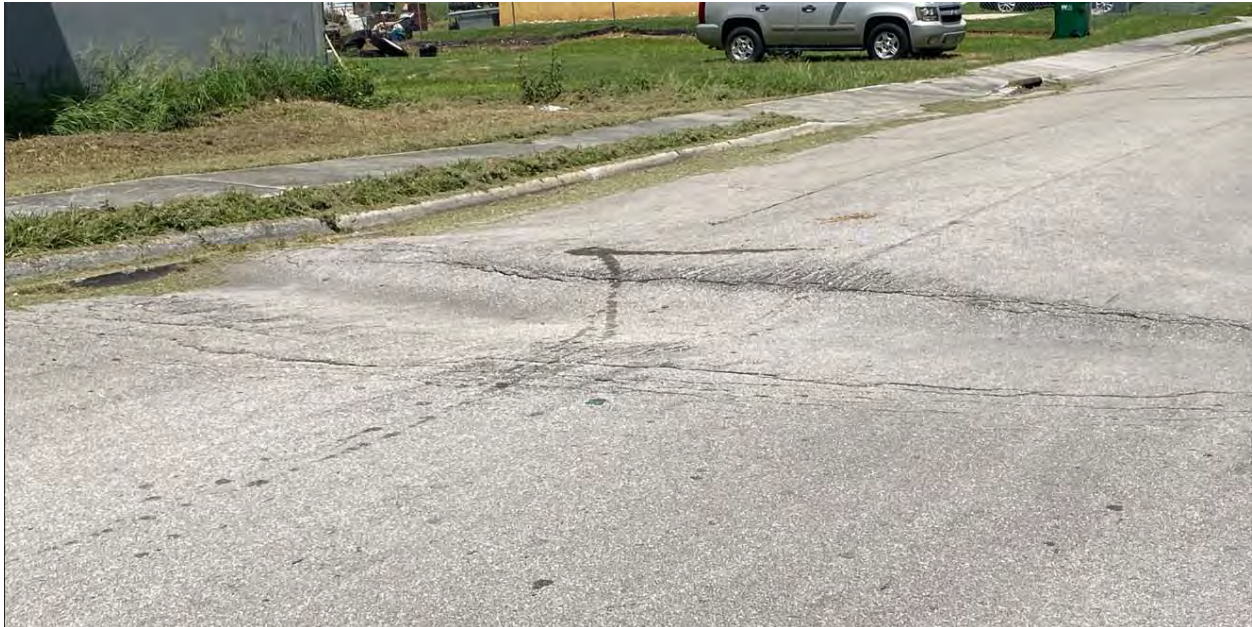
*Figure 4.1*

Depressions found on NW 11<sup>th</sup> avenue can mainly be attributed to movement of the roadway base and subbase. Consolidation or lateral movement under traffic in one or more of the underlying causes, or by displacement in the surface layer itself can cause similar depressions to form. Depressions such as those seen in Figure 4.1, Figure 4.2, and Figure 4.3 are of main concern along NW 11<sup>th</sup> avenue. These current conditions are currently causing drainage deficiencies that further affect the longevity of the road.

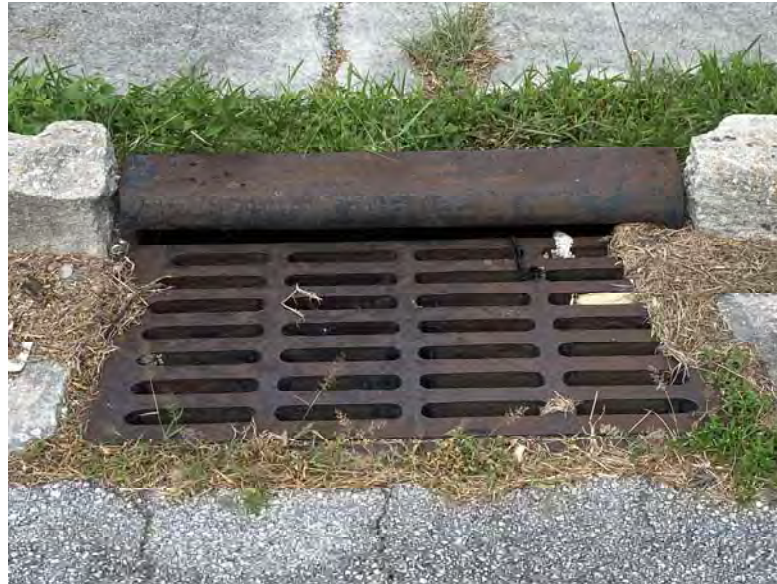
*Figure 4.4*

Proper drainage is essential to preserve the design life of the roadway. Although not shown due to dry conditions at the time of inspection, standing water on the pavement is a constant issue in this roadway due to the sinking observed at the intersection causing water to flow away from the inlets. Sinking of the road around inlets and curb and gutter has also severely impacted the ability to drain properly. Figures below show some of the conditions mentioned above.

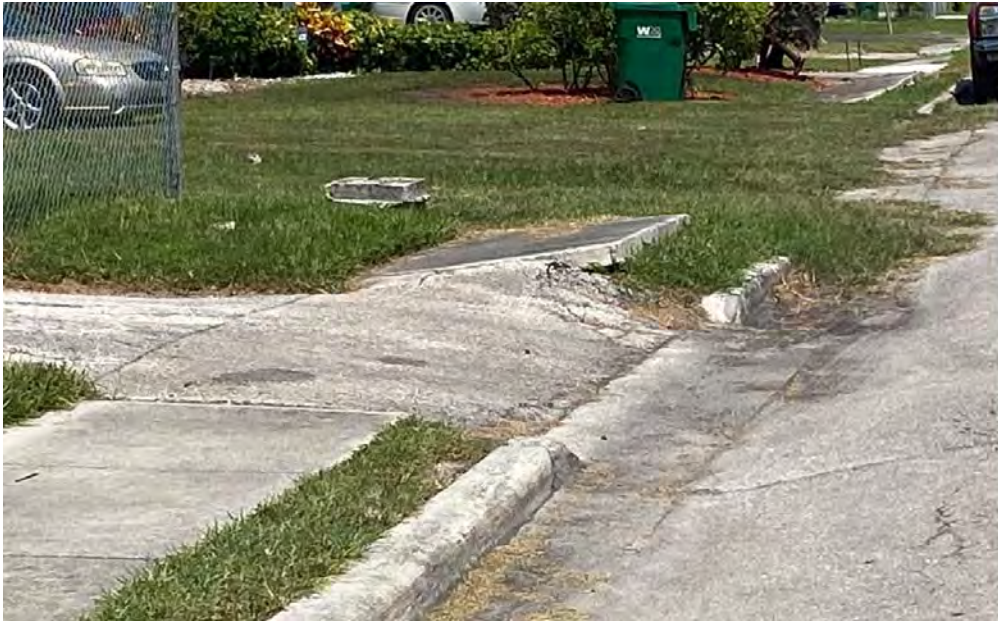
*Figure 4.6*

Sidewalk damage can be seen at multiple instances along NW 11<sup>th</sup> avenue. Conditions such as cracking and uneven settlement were observed. Probable causes to sidewalk deficiencies observed can be attributed to weak soil structure and or vehicular load. Many locations were observed to be unsafe and are a potential trip hazard that need to be addressed as soon as feasible. Conditions shown Figures 4.6, 4.7, 4.8, and 4.9 represent typical deficiencies found.

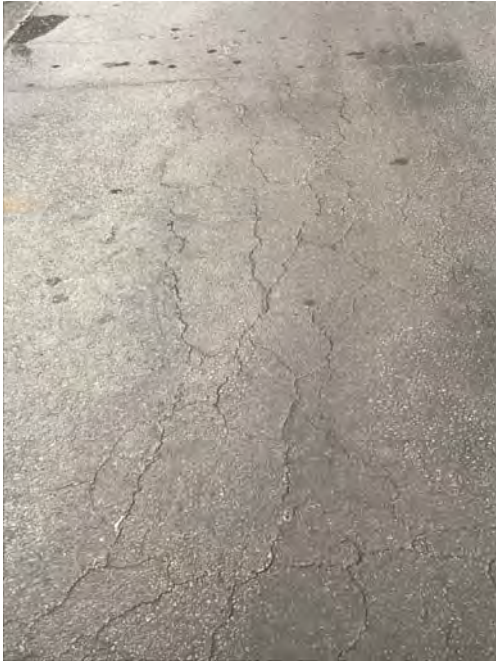
*Figure 7.0*

Figure 7.0 and Figure 7.1 below displays typical longitudinal cracks running a course approximately parallel to the centerline of the roadway. These cracks are result from earth movements, particularly on embankments. Two or more closely-spaced longitudinal cracks as shown in the figures below indicate bending stress induced by rutting. Longitudinal cracks can also occur as a result of movement in the pavement beneath the asphalt pavement layer (base and subbase settlement).

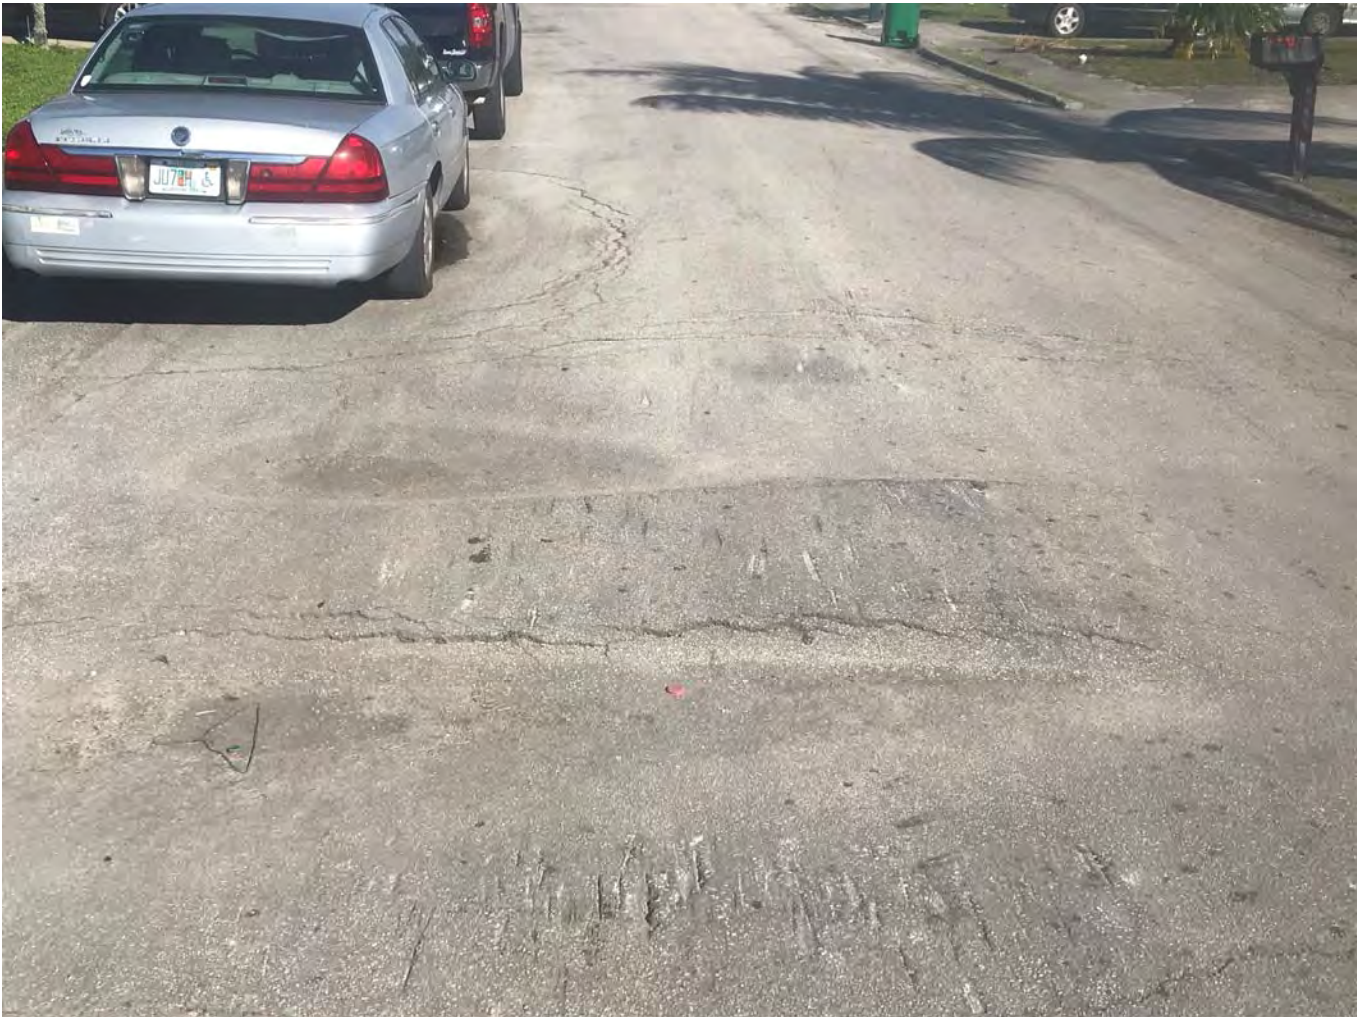
*Figure 7.2*

Depressions found on NW 12<sup>th</sup> avenue can mainly be attributed to movement of the roadway base and subbase. Consolidation or lateral movement under traffic in one or more of the underlying causes, or by displacement in the surface layer itself can cause similar depressions to form. Depressions such as those seen in Figure 7.2 and Figure 7.3 are of main concern along NW 12<sup>th</sup> avenue. These current conditions are currently causing drainage deficiencies that further affect the longevity of the road.

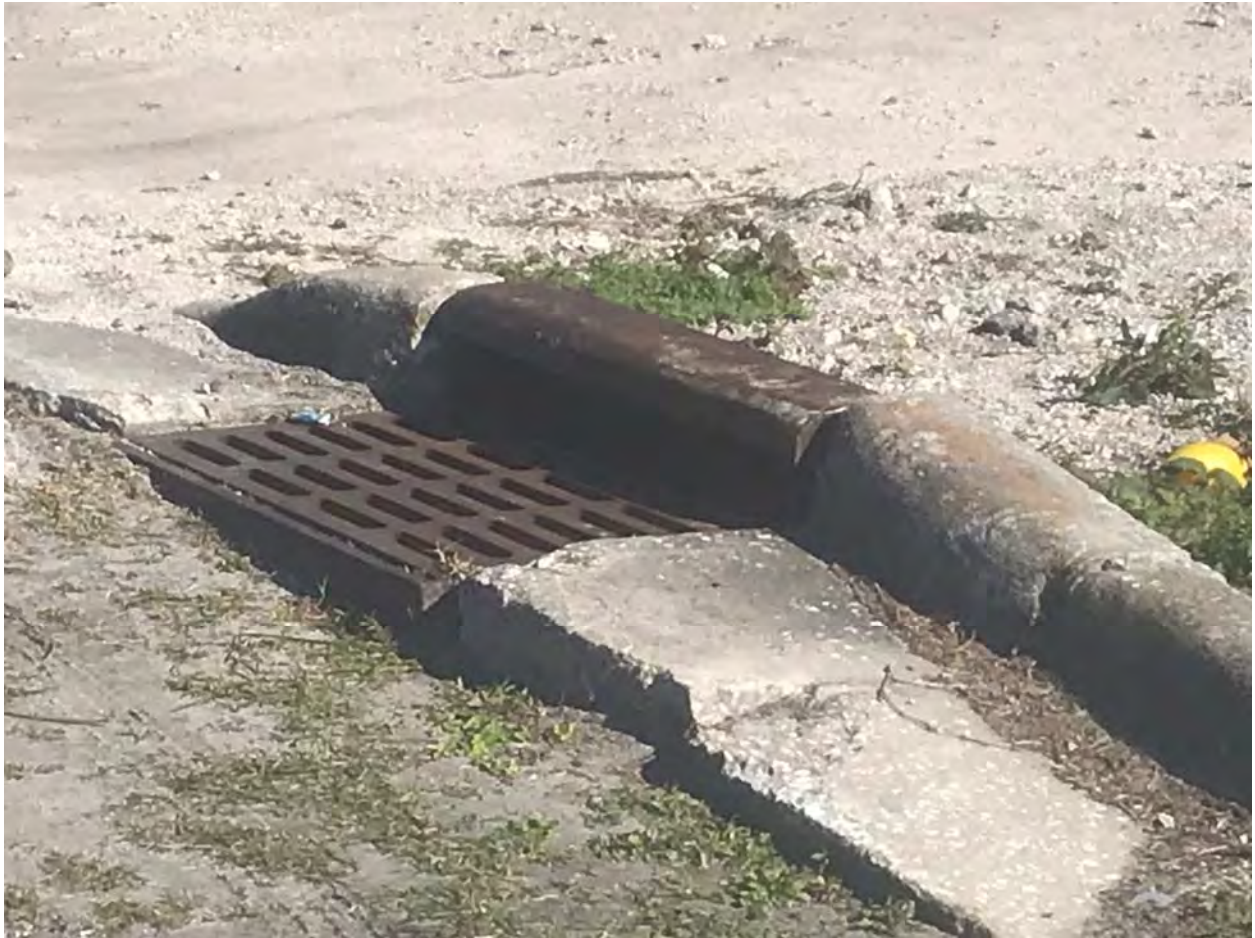
*Figure 7.4*

Proper drainage is essential to preserve the design life of the roadway. Although not shown due to dry conditions at the time of inspection, standing water on the pavement is a constant issue in this roadway due to the sinking observed at the intersection causing water to flow away from the inlets. Sinking of the road around inlets and curb and gutter has also severely impacted the ability to drain properly. Figures below some of the conditions mentioned above.

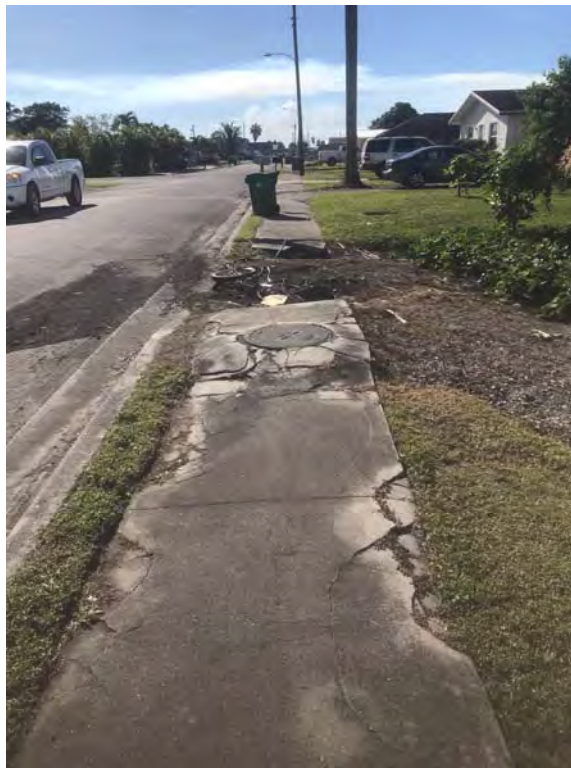
*Figure 7.6*

Sidewalk damage can be seen at multiple instances along NW 12<sup>th</sup> avenue. Conditions such as cracking and uneven settlement were observed. Probable causes to sidewalk deficiencies observed can be attributed to weak soil structure and or vehicular load. Many locations were observed to be unsafe and are a potential trip hazard that need to be addressed as soon as feasible. Conditions shown Figure 7.6, 7.7 and 7.8 represent typical deficiencies found.

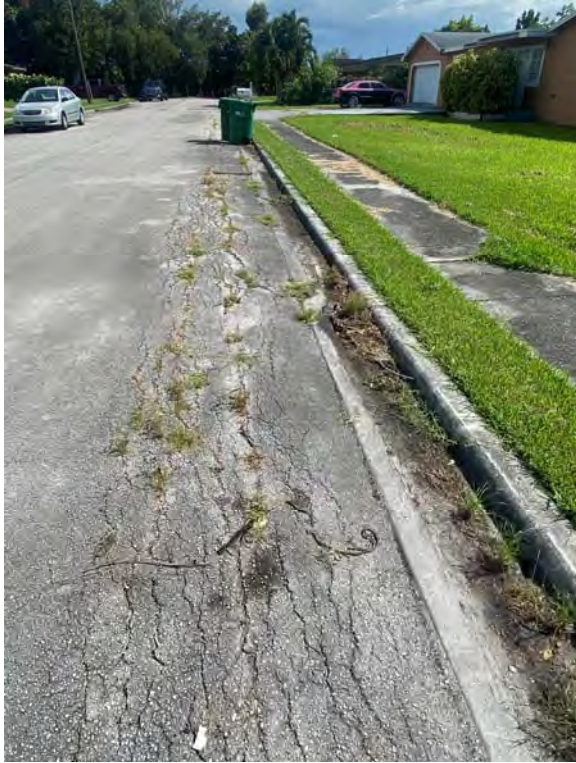
Figure 6.0 and Figure 6.1 below displays typical longitudinal cracks running a course approximately parallel to the centerline of the roadway. These cracks are result from earth movements, particularly on embankments. Two or more closely-spaced longitudinal cracks as shown in the figures below indicate bending stress induced by rutting. Longitudinal cracks can also occur as a result of movement in the pavement beneath the asphalt pavement layer (base and subbase settlement).

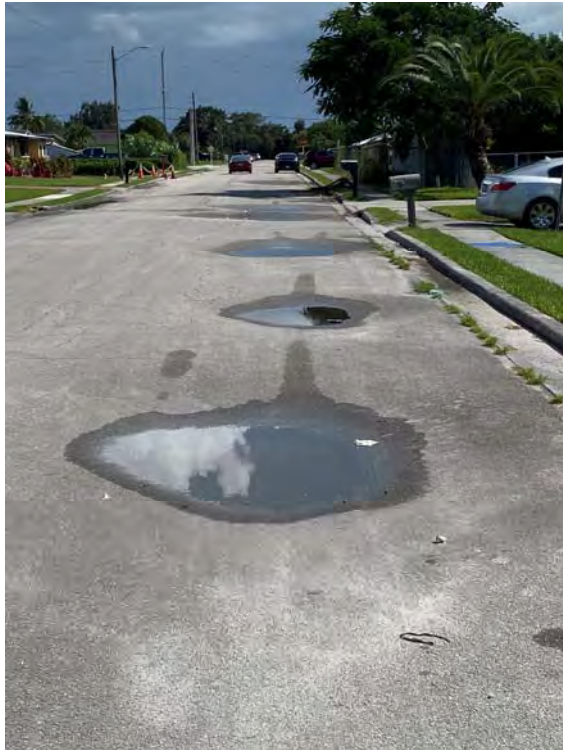
*Figure 6.2*

Depressions found on SW 5<sup>th</sup> avenue can mainly be attributed to movement of the roadway base and subbase. Consolidation or lateral movement under traffic in one or more of the underlying causes, or by displacement in the surface layer itself can cause similar depressions to form. Depressions such as those seen in Figure 6.2 and Figure 6.3 are of main concern along SW 5<sup>th</sup> avenue. These current conditions are currently causing drainage deficiencies that further affect the longevity of the road.

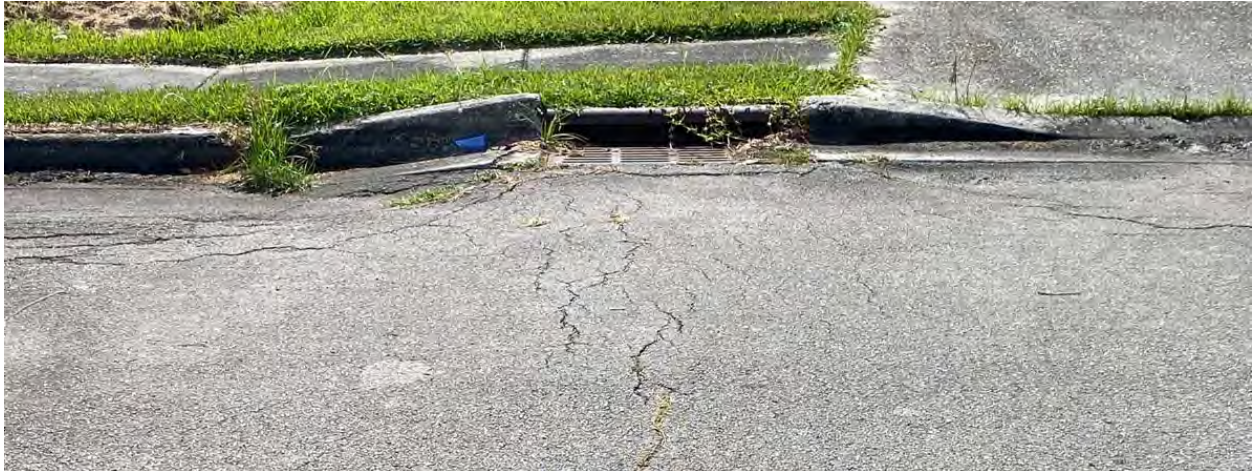
*Figure 6.4*

Proper drainage is essential to preserve the design life of the roadway. Although not shown due to dry conditions at the time of inspection, standing water on the pavement is a constant issue in this roadway due to the sinking observed at the intersection causing water to flow away from the inlets. Sinking of the road around inlets and curb and gutter has also severely impacted the ability to drain properly. Figures below show some of the conditions mentioned above.

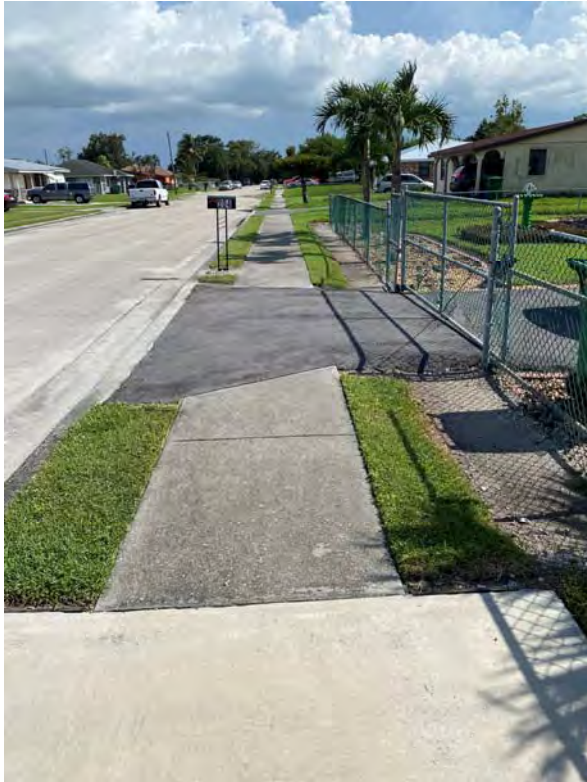
*Figure 6.6*

Sidewalk damage can be seen at multiple instances along SW 5<sup>th</sup> avenue. Conditions such as cracking and uneven settlement were observed. Probable causes to sidewalk deficiencies observed can be attributed to weak soil structure and or vehicular load. Many locations were observed to be unsafe and are a potential trip hazard that need to be addressed as soon as feasible. Conditions shown Figure 6.6 and 6.7 represent typical deficiencies found.

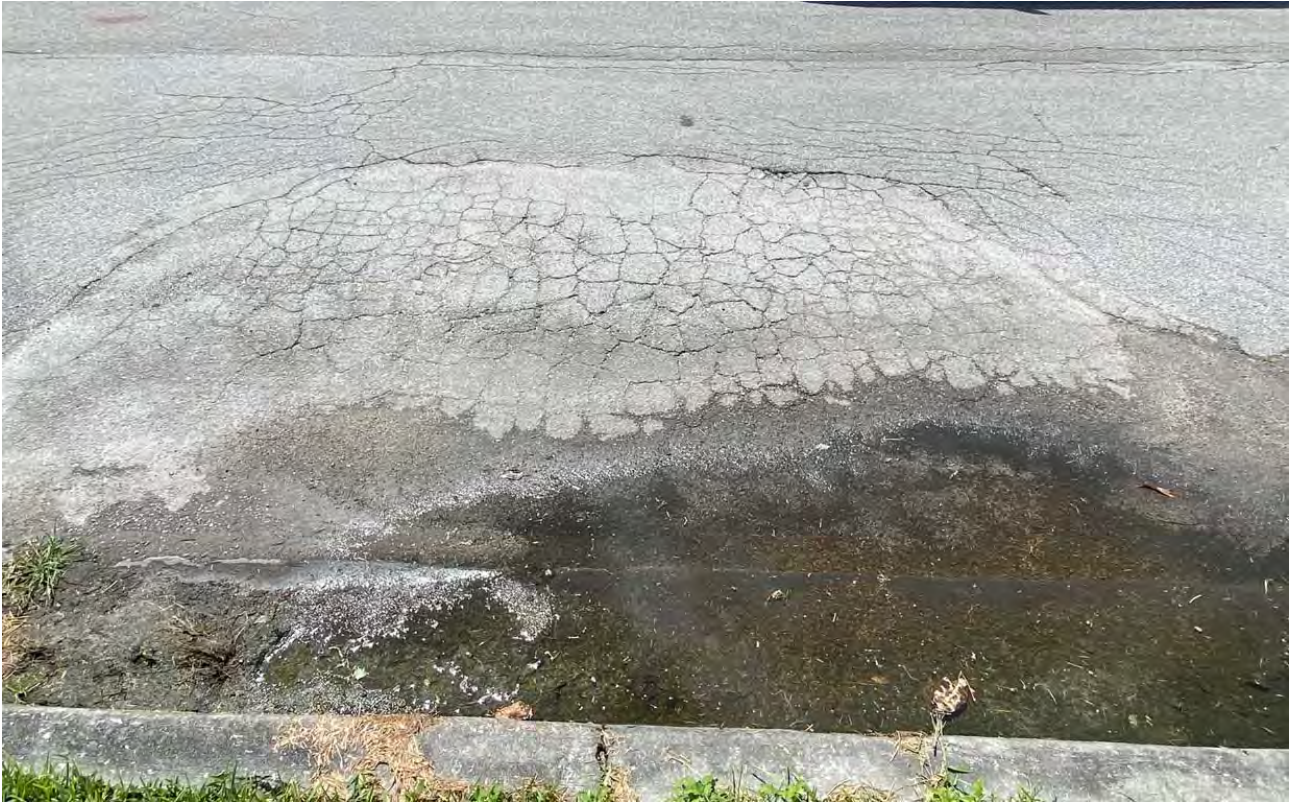
*Figure 5.0*

Figure 5.0 and Figure 5.1 below displays typical longitudinal cracks running a course approximately parallel to the centerline of the roadway. These cracks are result from earth movements, particularly on embankments. Two or more closely-spaced longitudinal cracks as shown in the figures below indicate bending stress induced by rutting. Longitudinal cracks can also occur as a result of movement in the pavement beneath the asphalt pavement layer (base and subbase settlement).

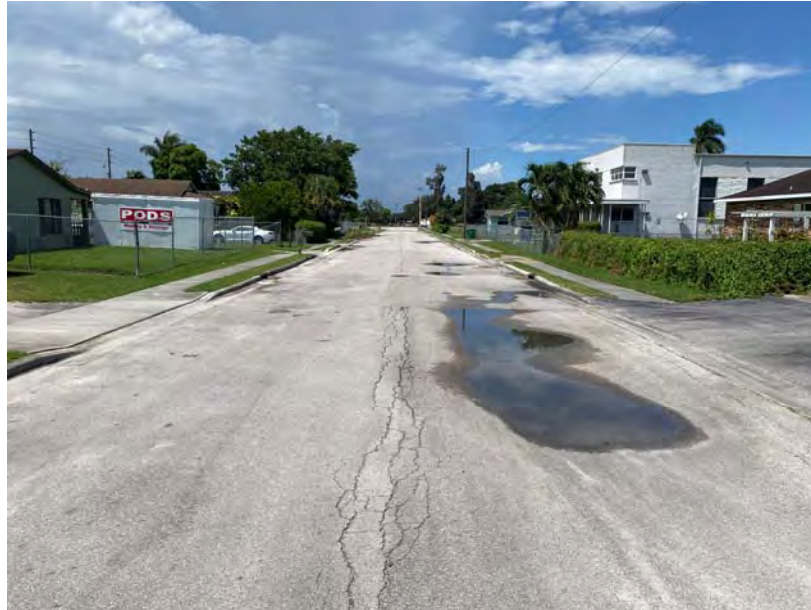
*Figure 5.2*

Depressions found on SW 6<sup>th</sup> avenue can mainly be attributed to movement of the roadway base and subbase. Consolidation or lateral movement under traffic in one or more of the underlying causes, or by displacement in the surface layer itself can cause similar depressions to form. Depressions such as those seen in Figure 5.2 and Figure 5.3 are of main concern along SW 6<sup>th</sup> avenue. These current conditions are currently causing drainage deficiencies that further affect the longevity of the road.

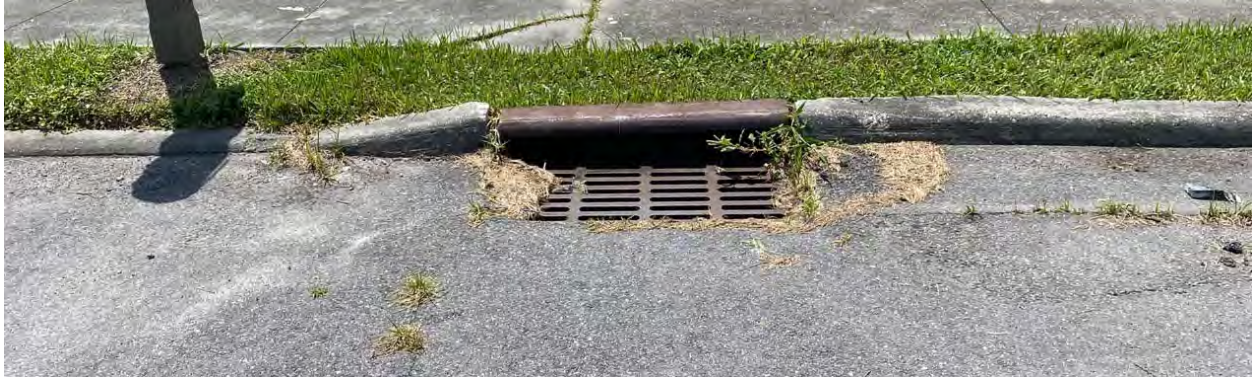
*Figure 5.4*

Proper drainage is essential to preserve the design life of the roadway. Although not shown due to dry conditions at the time of inspection, standing water on the pavement is a constant issue in this roadway due to the sinking observed at the intersection causing water to flow away from the inlets. Sinking of the road around inlets and curb and gutter has also severely impacted the ability to drain properly. Figures below show some of the conditions mentioned above.

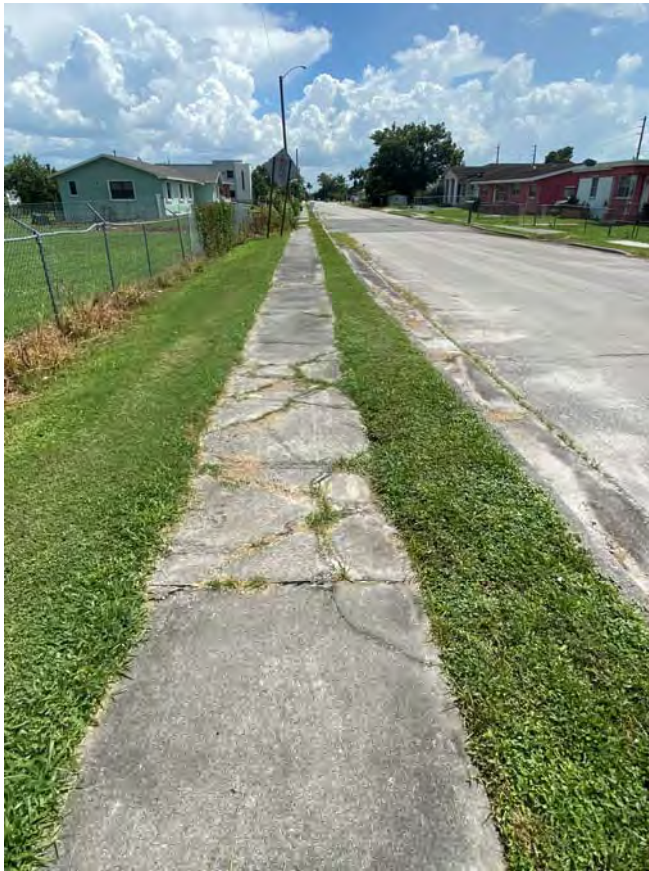
Figure 5.6

Sidewalk damage can be seen at multiple instances along SW 6<sup>th</sup> avenue. Conditions such as cracking and uneven settlement were observed. Probable causes to sidewalk deficiencies observed can be attributed to weak soil structure and or vehicular load. Many locations were observed to be unsafe and are a potential trip hazard that need to be addressed as soon as feasible. Conditions shown Figure 5.6, 5.7 and 5.8 represent typical deficiencies found.

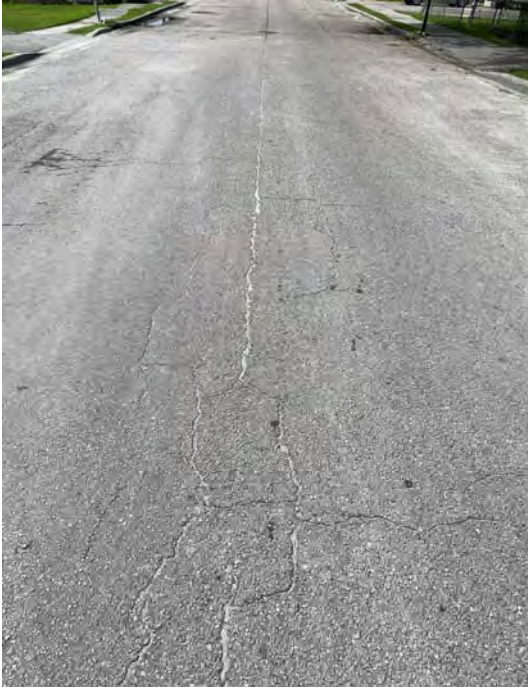
Figure 7.0 and Figure 7.1 below displays typical longitudinal cracks running a course approximately parallel to the centerline of the roadway. These cracks are result from earth movements, particularly on embankments. Two or more closely-spaced longitudinal cracks as shown in the figures below indicate bending stress induced by rutting. Longitudinal cracks can also occur as a result of movement in the pavement beneath the asphalt pavement layer (base and subbase settlement).

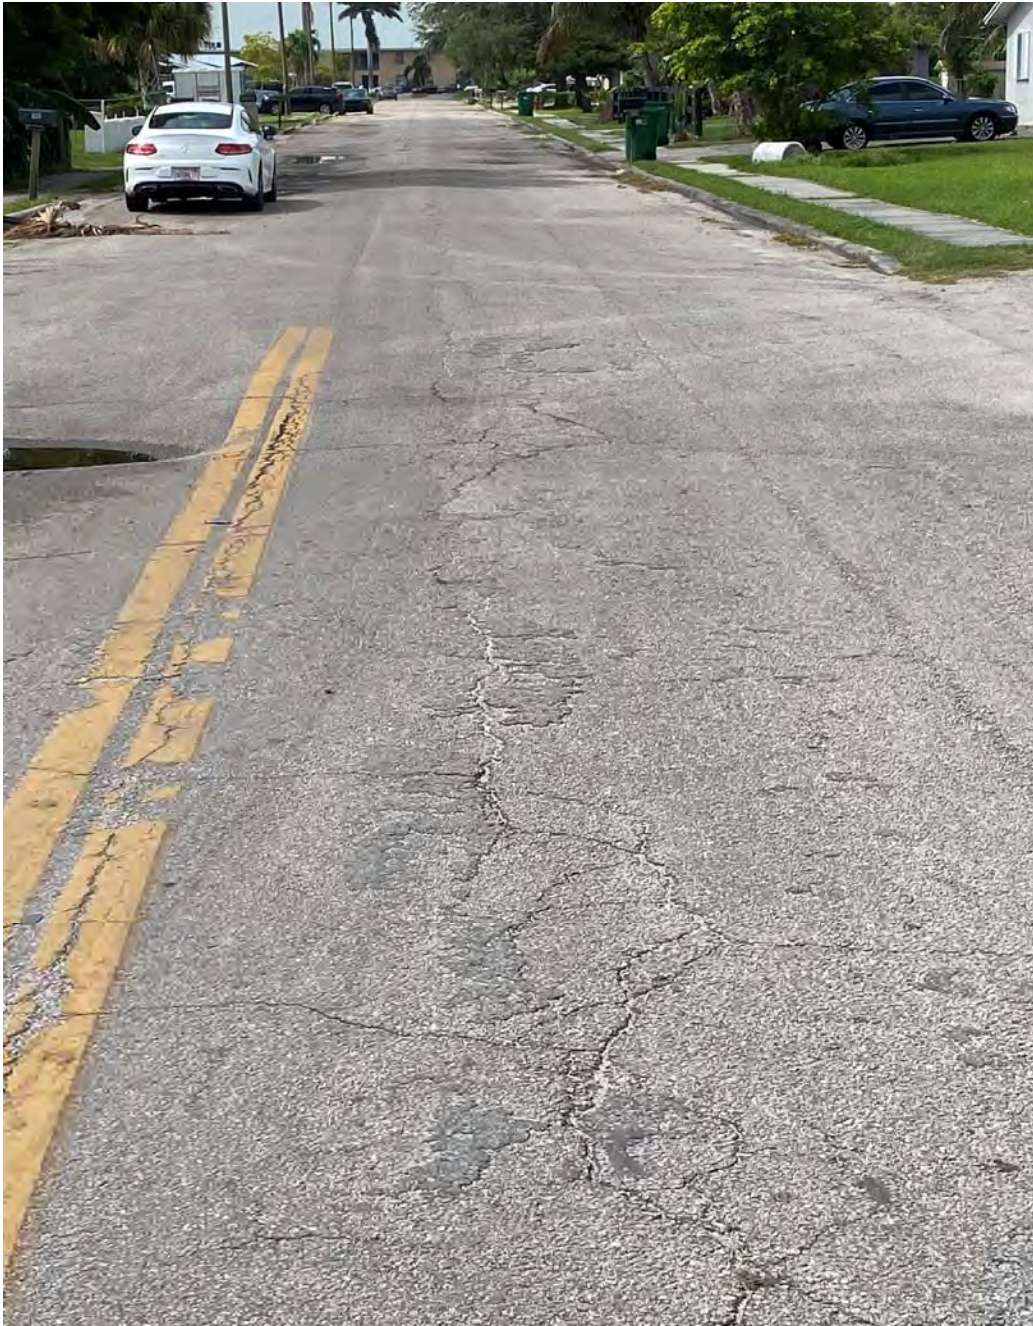
*Figure 7.2*

Depressions found on SW 11<sup>th</sup> avenue can mainly be attributed to movement of the roadway base and subbase. Consolidation or lateral movement under traffic in one or more of the underlying causes, or by displacement in the surface layer itself can cause similar depressions to form. Depressions such as those seen in Figure 7.2 and Figure 7.3 are of main concern along SW 11<sup>th</sup> avenue. These current conditions are currently causing drainage deficiencies that further affect the longevity of the road.
