## **TECHNICAL MEMORANDUM**

**From:** Mohan Thampi, PE, Project Manager, CAP Engineering  
Rolando Alvarez, EI, Project Engineer, CAP Engineering

**RE:** **Evaluation of Options for Possible Immediate Road Repairs for NW 6<sup>th</sup> Avenue, NW 7<sup>th</sup> Avenue, NW 9<sup>th</sup> Avenue, NW 10<sup>th</sup> Avenue, NW 11<sup>th</sup> Avenue, NW 12<sup>th</sup> Avenue, SW 5<sup>th</sup> Avenue, and SW 6<sup>th</sup> Avenue, and SW 11<sup>th</sup> Avenue (DRAFT)**

### 1. NW 6<sup>th</sup> Ave Evaluation

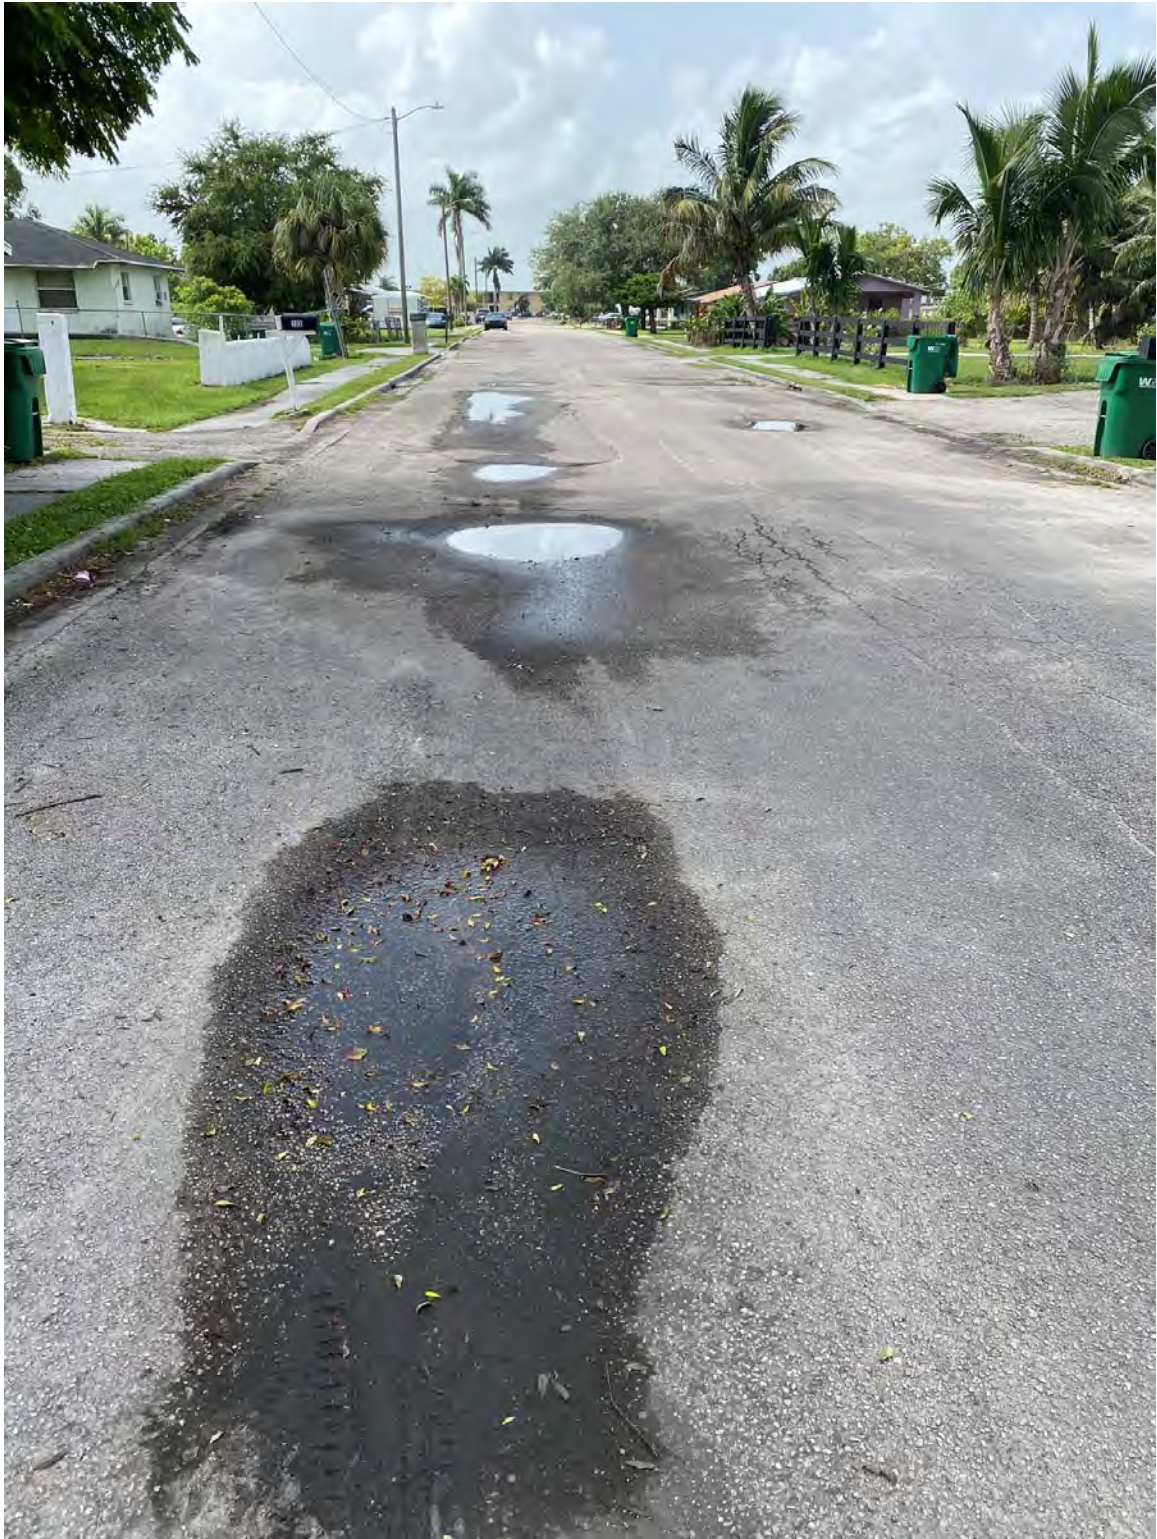
Depressions found on SW 11<sup>th</sup> avenue can mainly be attributed to movement of the roadway base and subbase. Consolidation or lateral movement under traffic in one or more of the underlying causes, or by displacement in the surface layer itself can cause similar depressions to form. Depressions such as those seen in Figure 7.2 and Figure 7.3 are of main concern along SW 11<sup>th</sup> avenue. These current conditions are currently causing drainage deficiencies that further affect the longevity of the road.

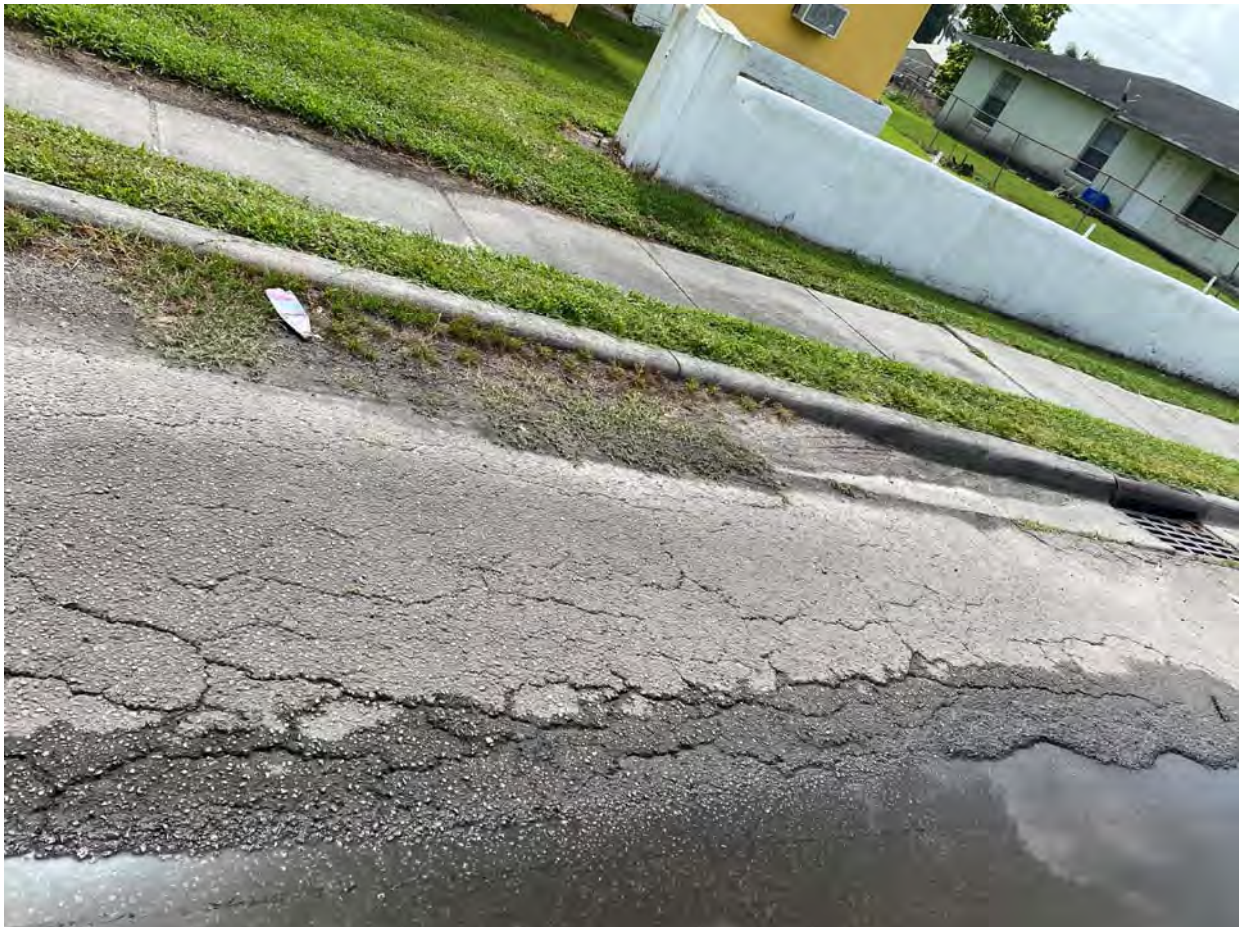
*Figure 7.4*

Proper drainage is essential to preserve the design life of the roadway. Although not shown due to dry conditions at the time of inspection, standing water on the pavement is a constant issue in this roadway due to the sinking observed at the intersection causing water to flow away from the inlets. Sinking of the road around inlets and curb and gutter has also severely impacted the ability to drain properly. Figures below some of the conditions mentioned above.

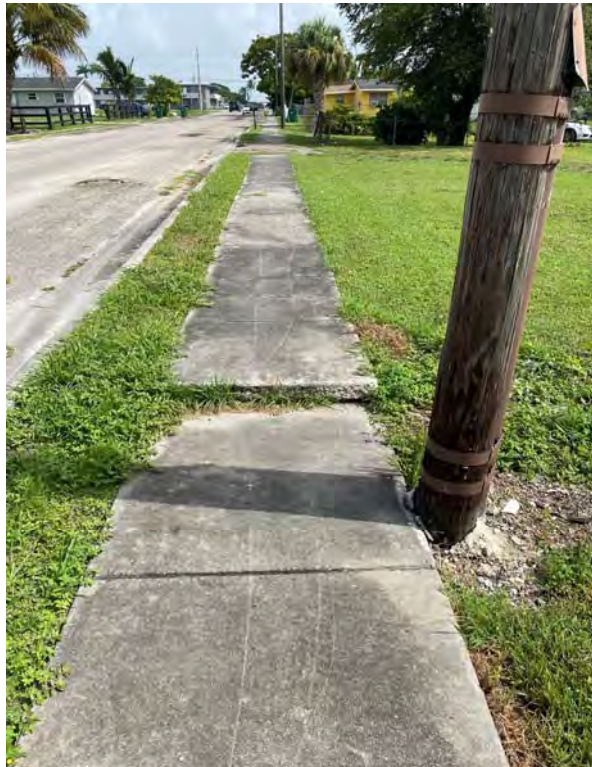
Figure 7.6

Sidewalk damage can be seen at multiple instances along SW 11<sup>th</sup> avenue. Conditions such as cracking and uneven settlement were observed. Probable causes to sidewalk deficiencies observed can be attributed to weak soil structure and or vehicular load. Many locations were observed to be unsafe and are a potential trip hazard that need to be addressed as soon as feasible. Conditions shown Figure 7.6, 7.7 and 7.8 represent typical deficiencies found.
