## **TECHNICAL MEMORANDUM**

**From:** Mohan Thampi, PE, Project Manager, CAP Engineering  
Rolando Alvarez, EI, Project Engineer, CAP Engineering

**RE:** **Evaluation of Options for Possible Immediate Road Repairs for NW 6<sup>th</sup> Avenue, NW 7<sup>th</sup> Avenue, NW 9<sup>th</sup> Avenue, NW 10<sup>th</sup> Avenue, NW 11<sup>th</sup> Avenue, NW 12<sup>th</sup> Avenue, SW 5<sup>th</sup> Avenue, and SW 6<sup>th</sup> Avenue, and SW 11<sup>th</sup> Avenue (DRAFT)**

### 1. NW 6<sup>th</sup> Ave Evaluation

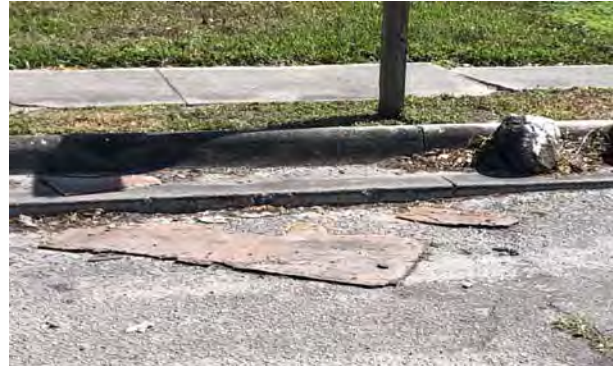
*Figure 1.5*

Proper drainage is essential to preserve the design life of the roadway. Although not shown due to dry conditions at the time of inspection, standing water on the pavement is a constant issue in this roadway due to the sinking observed at the intersection causing water to flow away from the inlets. Sinking of the road around inlets and curb and gutter has also severely impacted the ability to drain properly. Figures below some of the conditions mentioned above.

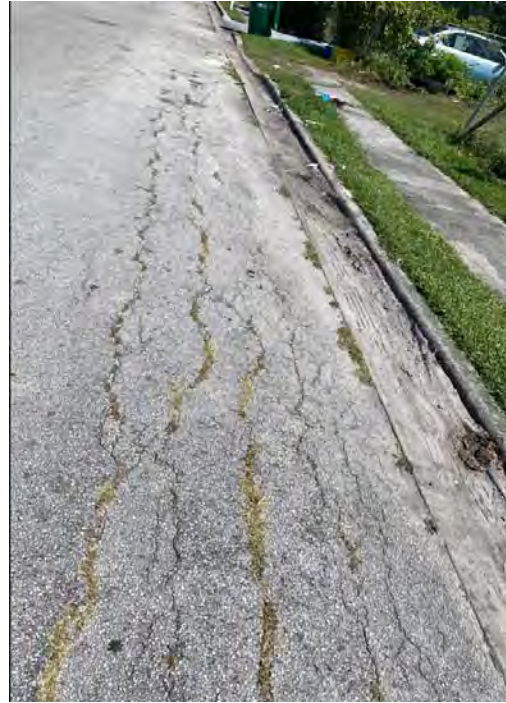
Figure 3.0 and Figure 3.1 below displays typical longitudinal cracks running a course approximately parallel to the centerline of the roadway. These cracks are result from earth movements, particularly on embankments. Two or more closely-spaced longitudinal cracks as shown in the figures below indicate bending stress induced by rutting. Longitudinal cracks can also occur as a result of movement in the pavement beneath the asphalt pavement layer (base and subbase settlement).

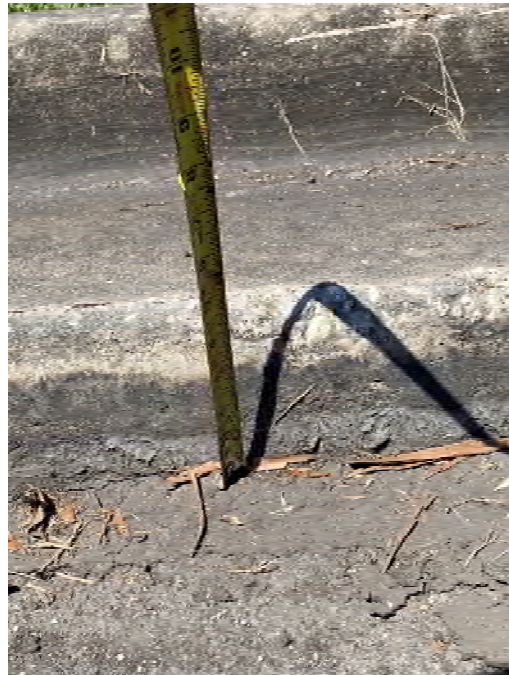
Figure 3.6

Sidewalk damage can be seen at multiple instances along NW 9<sup>th</sup> avenue. Conditions such as cracking and uneven settlement were observed. Probable causes to sidewalk deficiencies observed can be attributed to weak soil structure and or vehicular load. Many locations were observed to be unsafe and are a potential trip hazard that need to be addressed as soon as feasible. Conditions shown Figure 3.5-3.9 represent typical deficiencies found.

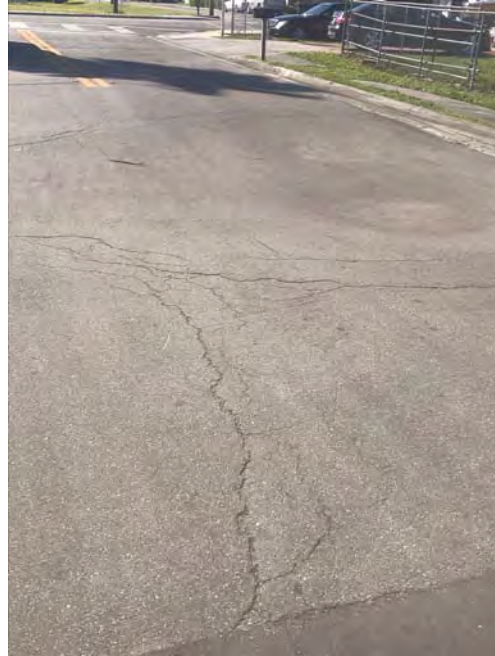
*Figure 7.1*

Figure 7.0 and Figure 7.1 below displays typical longitudinal cracks running a course approximately parallel to the centerline of the roadway. These cracks are result from earth movements, particularly on embankments. Two or more closely-spaced longitudinal cracks as shown in the figures below indicate bending stress induced by rutting. Longitudinal cracks can also occur as a result of movement in the pavement beneath the asphalt pavement layer (base and subbase settlement).

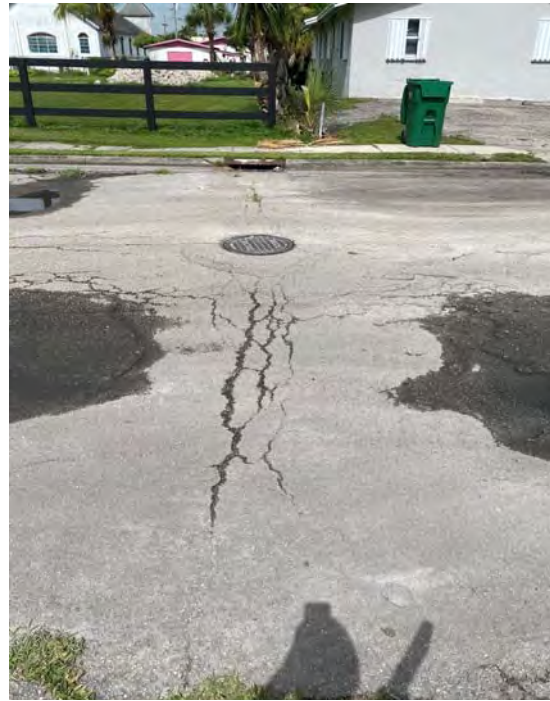
Figure 7.0 and Figure 7.1 below displays typical longitudinal cracks running a course approximately parallel to the centerline of the roadway. These cracks are result from earth movements, particularly on embankments. Two or more closely-spaced longitudinal cracks as shown in the figures below indicate bending stress induced by rutting. Longitudinal cracks can also occur as a result of movement in the pavement beneath the asphalt pavement layer (base and subbase settlement).

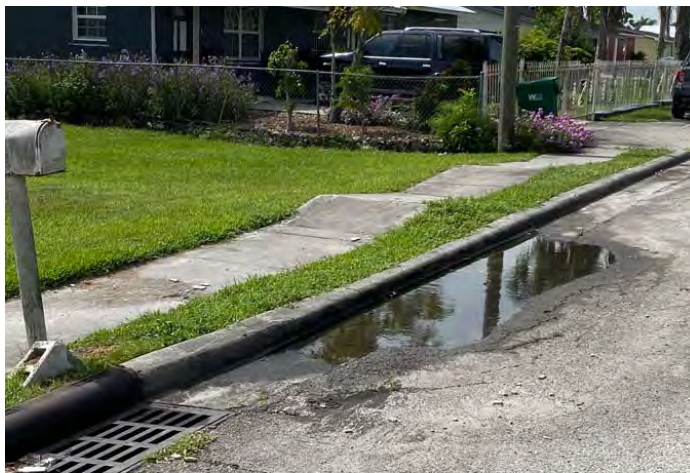
Figure 1.7

Sidewalk damage can be seen at multiple instances along SW 11<sup>th</sup> avenue. Conditions such as cracking and uneven settlement were observed. Probable causes to sidewalk deficiencies observed can be attributed to weak soil structure and or vehicular load. Many locations were observed to be unsafe and are a potential trip hazard that need to be addressed as soon as feasible. Conditions shown Figure 7.6, 7.7 and 7.8 represent typical deficiencies found.
